Evaluation of the Tetra Multifunctional Semi-automatic Tree Planter on Two Sites in Quebec

B. J. Sutherland

Information Report O-X-394
Great Lakes Forestry Centre

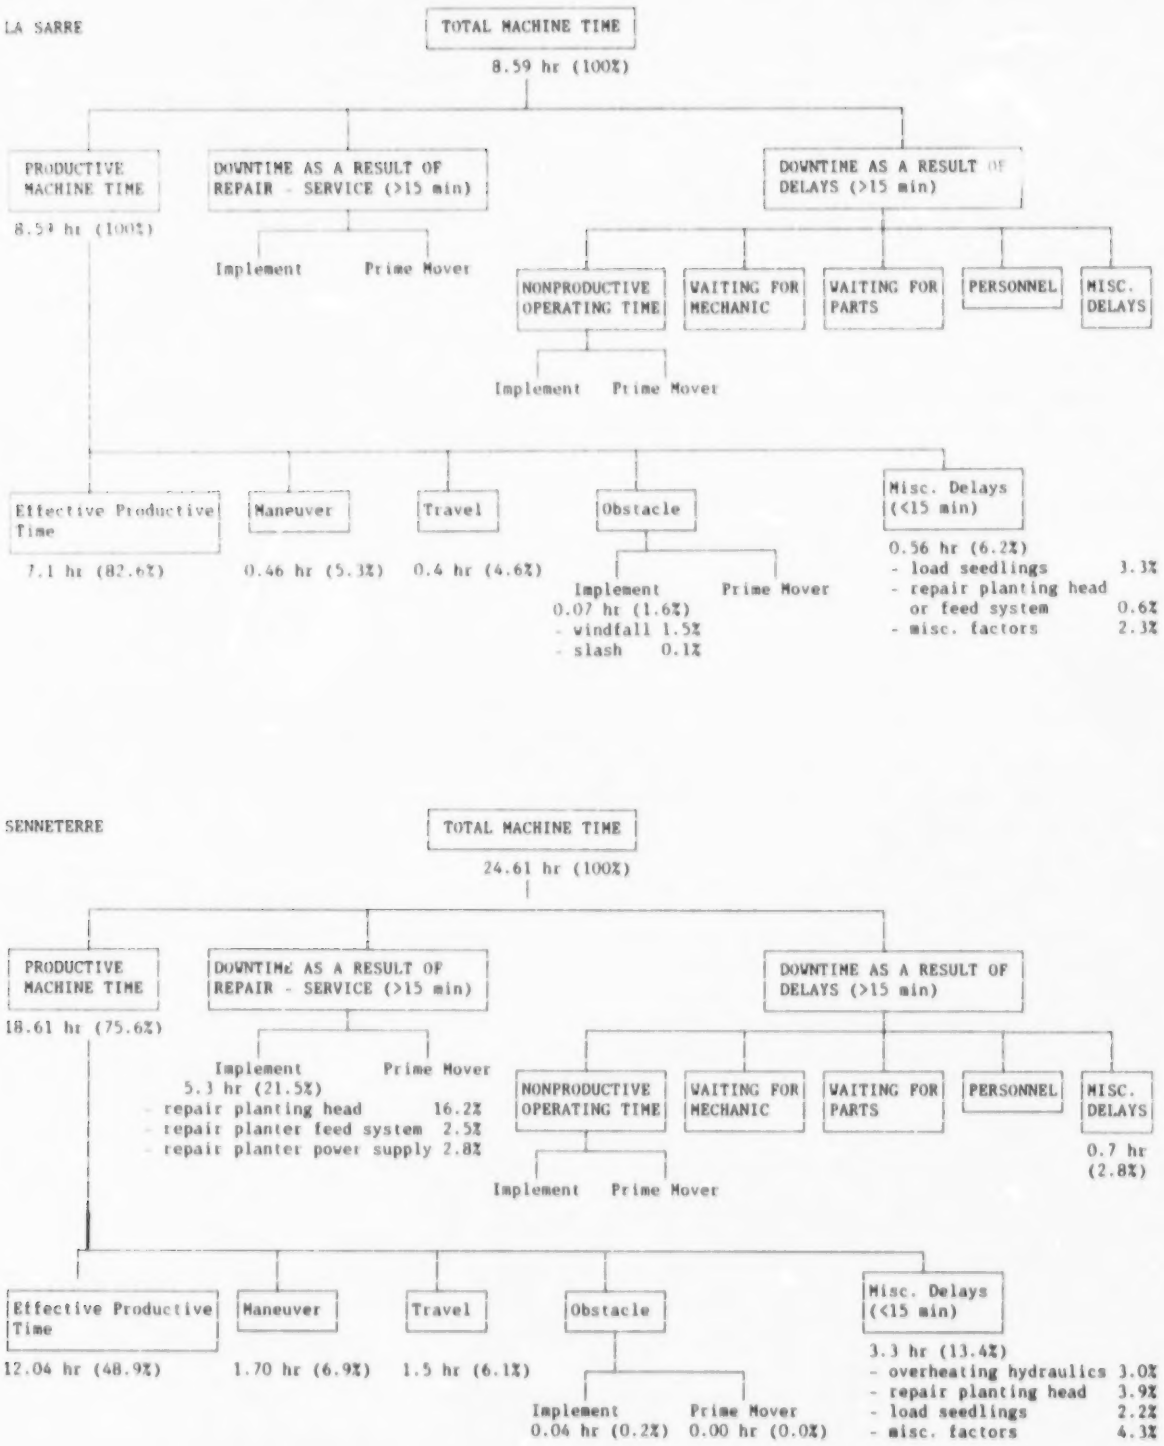
Figure 18. Results of continuous time study at Senneterre and La Sarre.

The results, including sources and cumulative time of delays, are shown in Figure 18 for both sites. The only major sources of downtime due to active repair at Senneterre were repairs to the planting head, feed system and planter power supply, which amounted to 21.5% of total machine time. A series of other short-term delays caused by overheating hydraulics, repairs to the planting head, loading of seedlings and other miscellaneous factors accounted for an additional 13.4% of total machine time. At La Sarre miscellaneous delays accounted for 6.2% of total machine time and were caused by the same factors as at Senneterre. Turning with the planting head in a raised position averaged 1.42 min at Senneterre and 1.31 min at La Sarre.

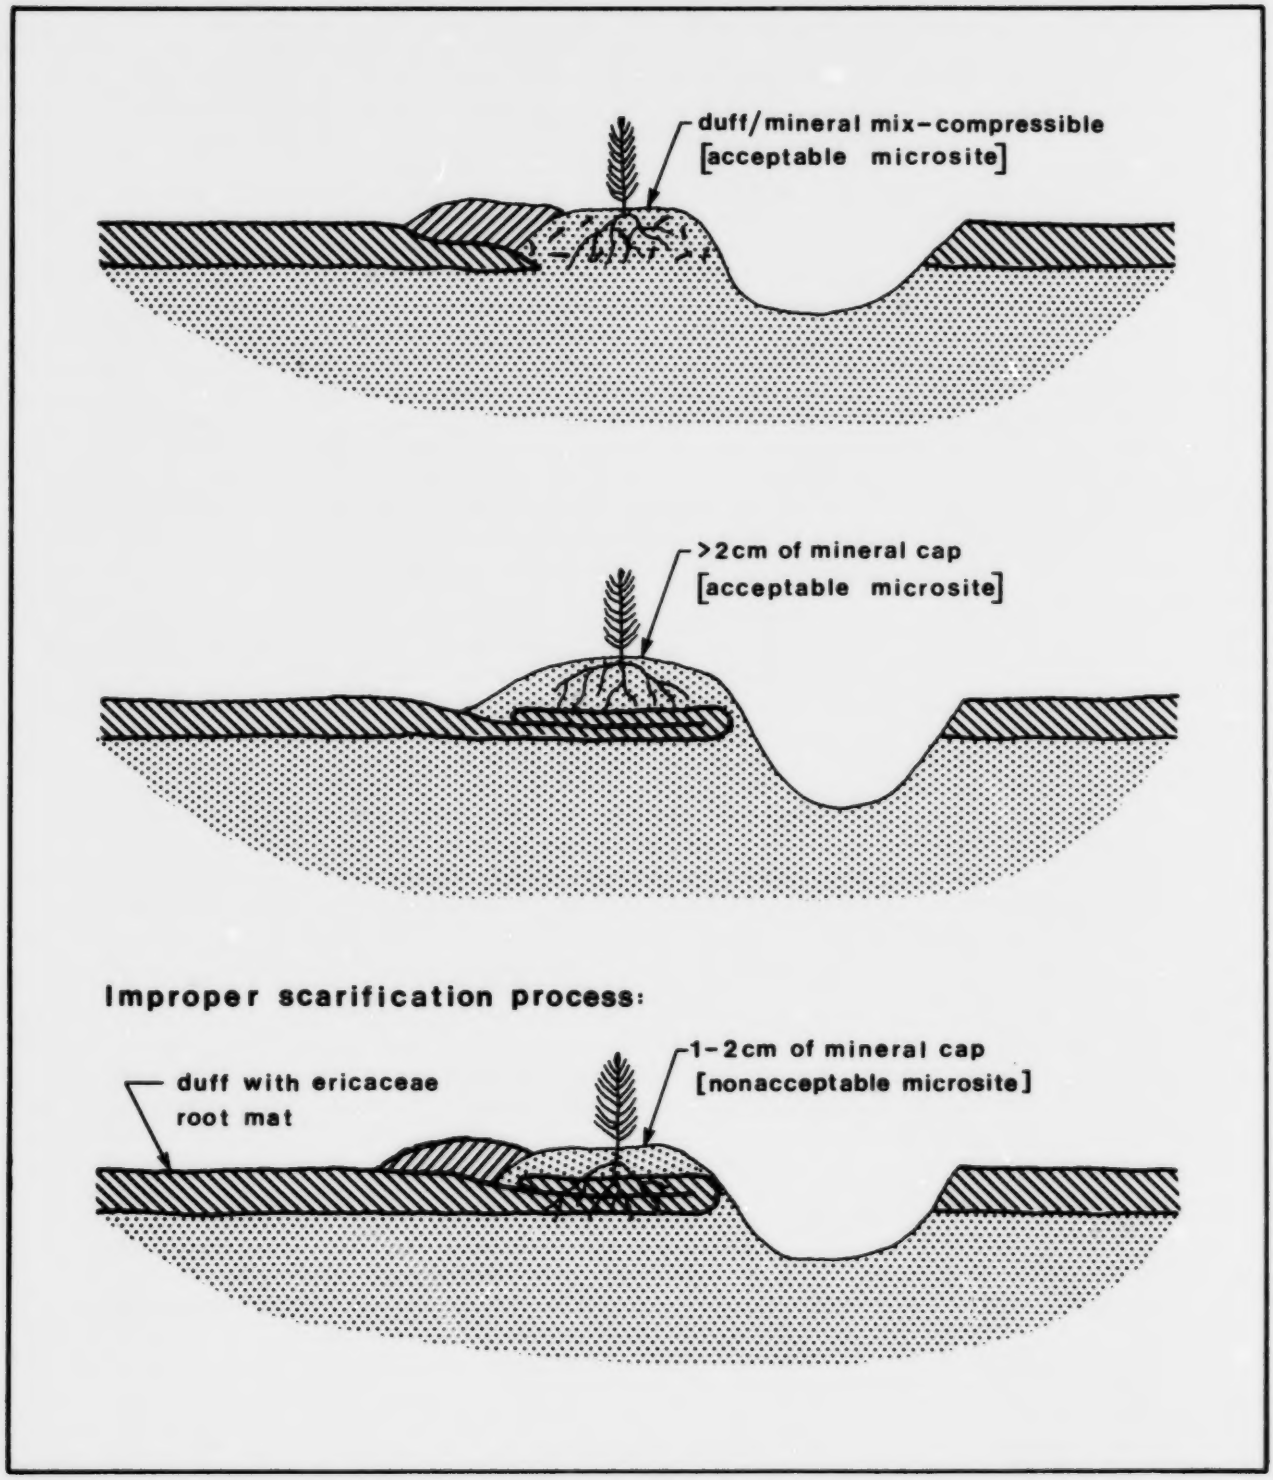
Figure 19. Scarification profiles of the Tetra scarification discs.

The scarification objective of the Tetra, that is, of mineral soil deposited on top of inverted duff, was not achieved under the site conditions that existed at Senneterre (Fig. 19). Often the inverted duff layer was produced but with no mineral soil or < 2 cm of mineral soil on top; hence, the term "improper scarification process". This duff/mineral soil sandwich was then compressed by the bogie wheel assembly and the planting cycle was executed, and as a result, seedlings were often planted shallowly (i.e., 68% had the root collar above the original humus/mineral soil interface) and loosely (i.e., 35% did not have sufficient packing). In an attempt to improve the scarification process at La Sarre the scarifier was operated with the secondary discs rotating passively (i.e., with no hydraulic power) so as to reduce the amount of material thrown up by the secondary discs. This adjustment was successful in reducing the mounding of duff material but planting quality improved only from 35% to 46% at La Sarre. The greater duff depth and slash loading at La Sarre were more limiting factors, causing inadequate depth of scarification, which accounted for 70% of the cases in which planting quality was less than satisfactory.

machines can still not choose planting spots in mineral soil". At Senneterre and La Sarre a high percentage of unsuitable microsites was created along the path followed by the planting head. Meanwhile, acceptable microsites were often found adjacent to the unsuitable sites. This reveals that scarification is not uniform or continuous in these site conditions. Moving the planting heads laterally to plant along a different path where there are more suitable microsites is one possible solution for improving planting quality without modifying the equipment. This does not, however, solve the overriding problem of the inability of the scarifiers to give consistent results.

Possible causes of the poor scarification results at Senneterre are ineffective tooth length on the scarification discs, and disc arms that are not hydraulically weighted to increase penetration force. A similar conclusion was drawn from the Swedish study. At La Sarre the combination of thicker duff and more debris prevented a proper scarification result.

The results of this study indicate that the Tetra tree planter is still in the developmental stage and not yet suitable for operational use under the site conditions described herein. Modifications to improve the scarification process alone should result in a dramatic improvement in planting quality.
